SOUTHWEST RESEARCH INST SAN ANTONIO TEX
DEVELOPMENT OF DIAGNOSTIC TEST EQUIPMENT FOR INSPECTING ANTIFRI--ETC(U)
MAR 77 F N KUSENBERGER, J R BARTON

March 1977

4. TITLE (and Subtitle) DEVELOPMENT OF DIAGNOSTIC TEST EQUIPMENT FOR INSPECTING ANTI- FRICTION BEARINGS ✓		5. TYPE OF REPORT & PERIOD COVERED Final Report, Sept. 19, 1973 to Feb. 28, 1977 ✓

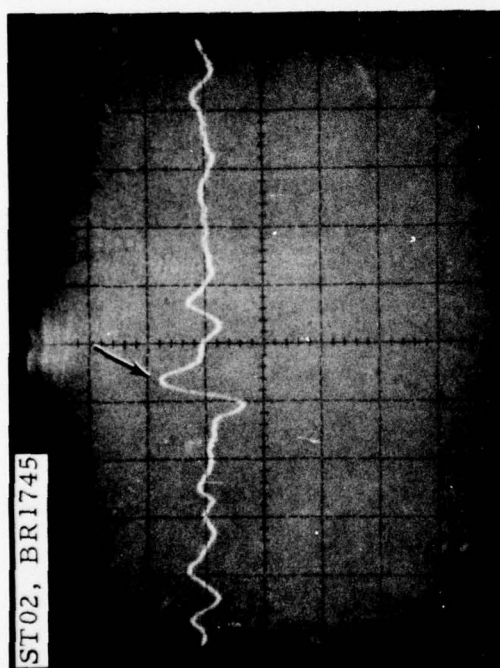
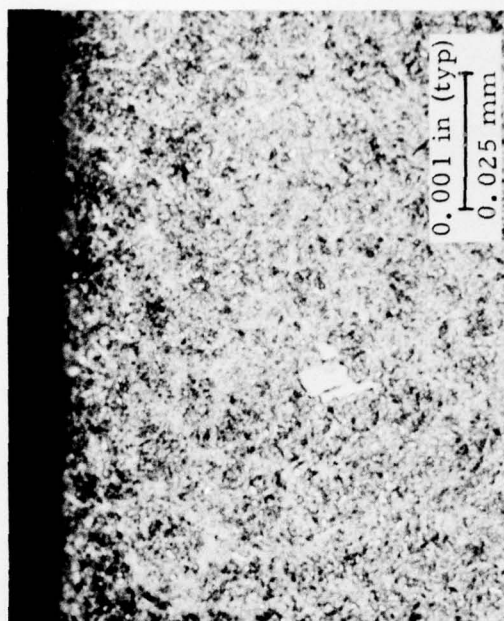
FIGURE 1. MAGNETIC PERTURBATION CIRCUMFERENTIAL SIGNATURE AND CORRESPONDING SUBSURFACE FLAW, P/N 1-300-015, S/N 470V(2) INNER RACE (HALF)

sensitivity to geometrical type flaws (inclusions, pits, etc.); similar inspections conducted at reduced fields enhance the detectability of flaws having associated localized stresses (fatigue cracks, indents, etc.). Figure 1 illustrates the direct correlation which has been obtained between circumferential signals and corresponding inclusions through metallurgical sectioning. The inspection signature obtained from the flaw is pointed out by the arrow in the signal trace at the top of Figure 1. The photomicrographs at the bottom of the figure show the flaw which generated the signature, obtained by meticulous metallurgical sectioning of the bearing race at the location from which the signature was obtained. The average diameter of the flaw illustrated in Figure 1 is slightly less than 0.001-inch (0.025 mm).

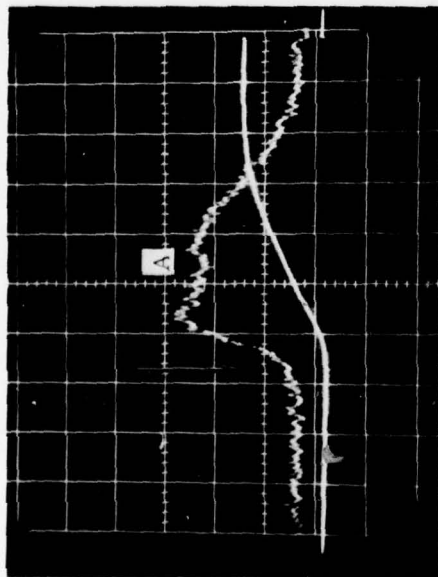
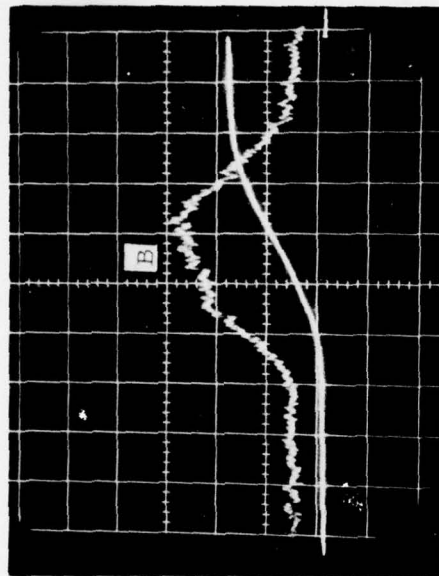
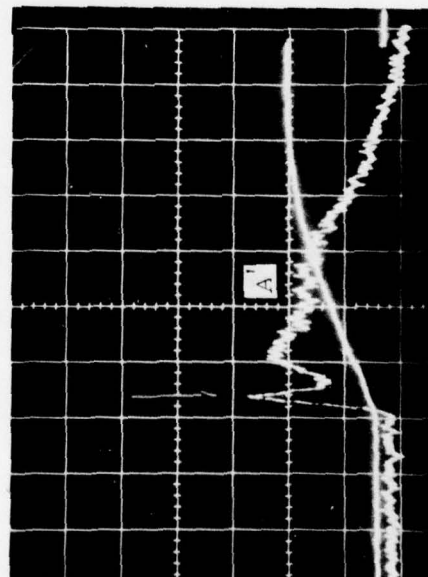
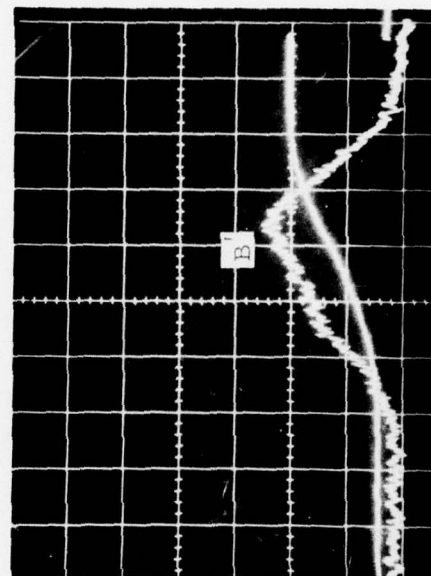
FIGURE 2. TYPICAL BARKHAUSEN RECORDS BEFORE AND AFTER APPROXIMATELY 1000 HOURS SERVICE ON A J85 MAIN SHAFT BEARING (S/N 07257)

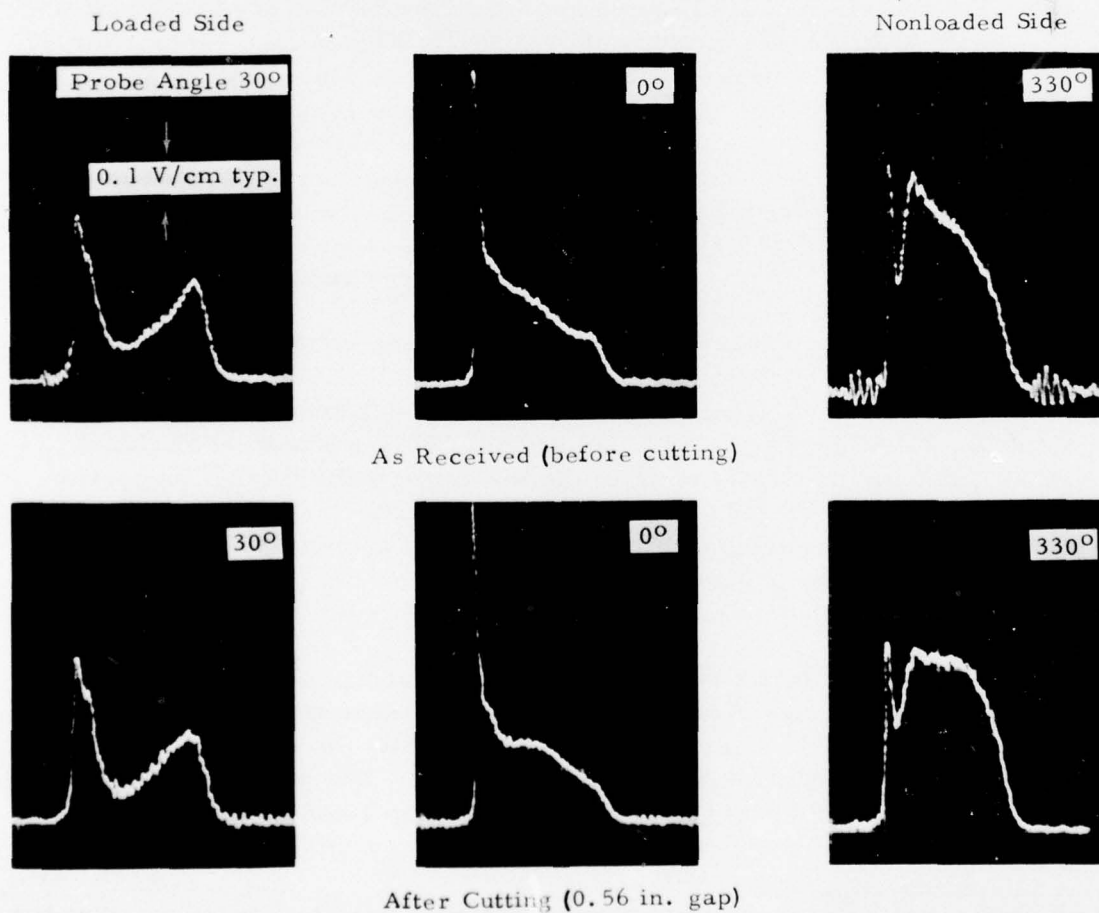
FIGURE 3A. BARKHAUSEN NOISE SIGNATURES BEFORE AND AFTER CUTTING A FAILED J85 MAIN BEARING (S/N 2416)

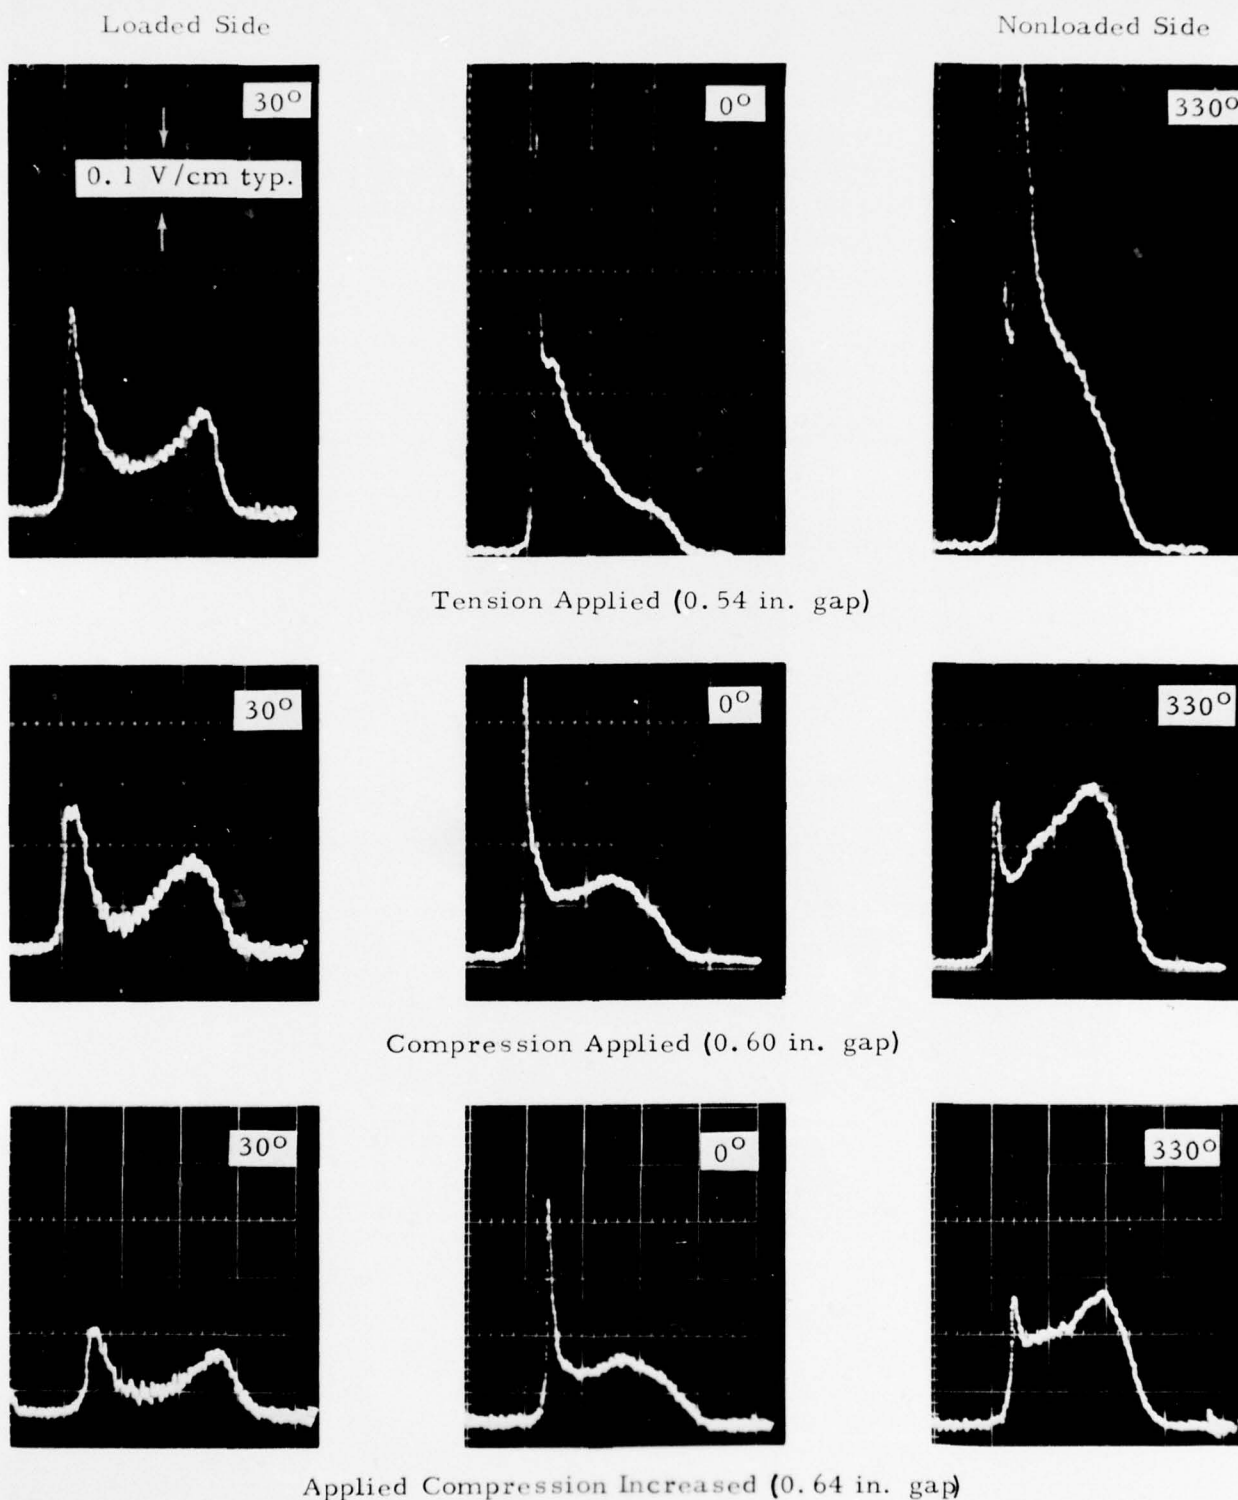
FIGURE 3B. BARKHAUSEN NOISE SIGNATURES WITH TENSION AND COMPRESSION APPLIED AFTER CUTTING A FAILED J85 BEARING (S/N 2416)

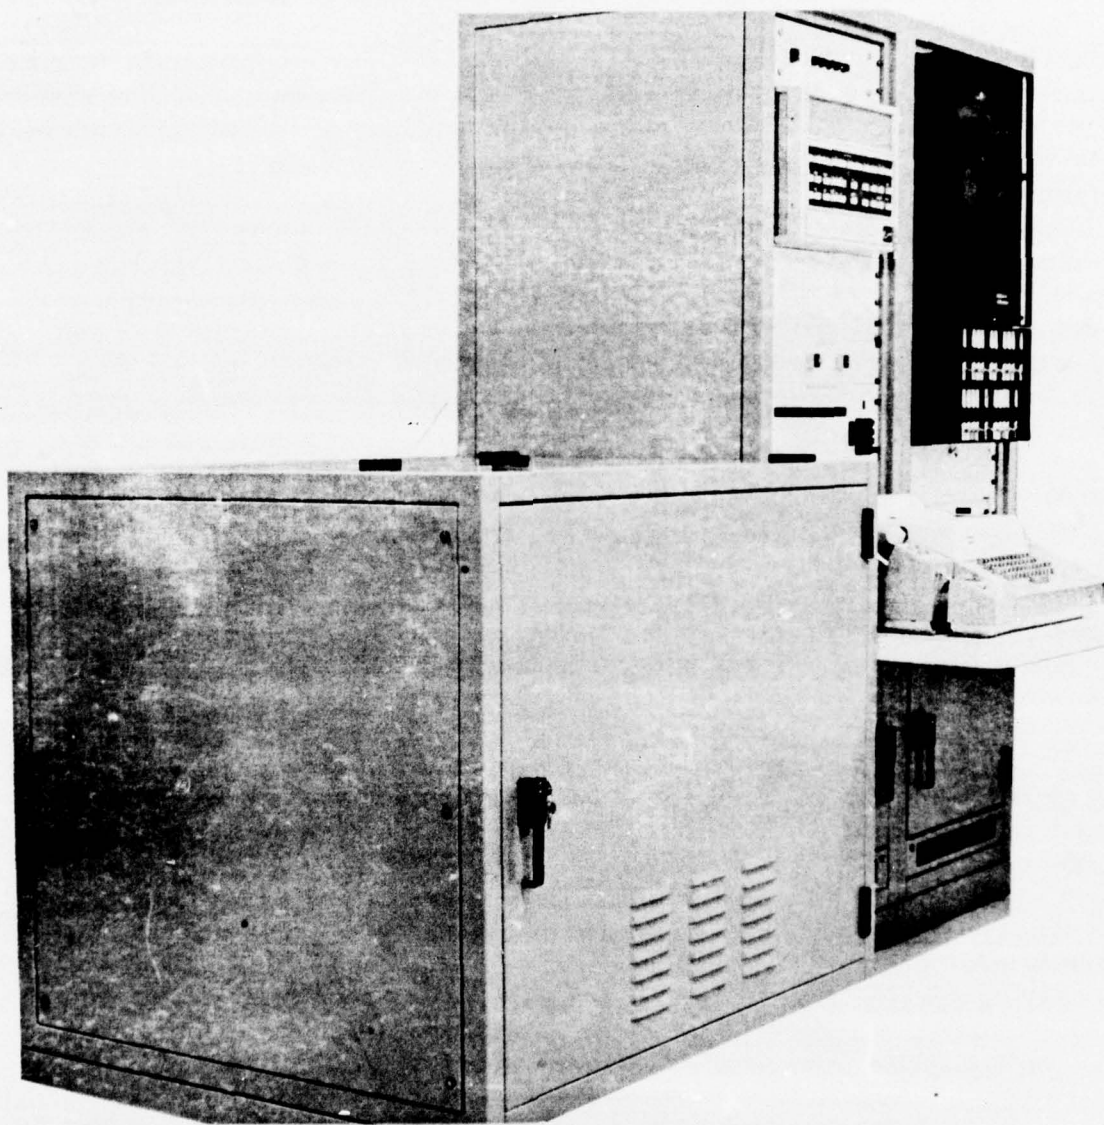
FIGURE 4. BEARING INSPECTION SYSTEM

The bearing inspection system, illustrated in Figure 4, employs magnetic perturbation and Barkhausen noise methods to inspect antifriction bearing race elements for surface and subsurface inclusions, indents, microcracks, spalls, and detrimental changes in residual stress, etc. The inspection system is semiautomatic; an operator performs such functions as mounting fixtures to accommodate the different bearing elements to be inspected and interfacing with a supervisory control computer. The computer acts in response to operator instructions and automatically controls and monitors inspection sequences. Data from all inspections are recorded on analog magnetic tape; simultaneously "threshold level" detection* signal analysis is performed automatically and the type and location (azimuthal and transverse) of all signals, which exceed the threshold level, are printed out in hard copy on a teleprinter.

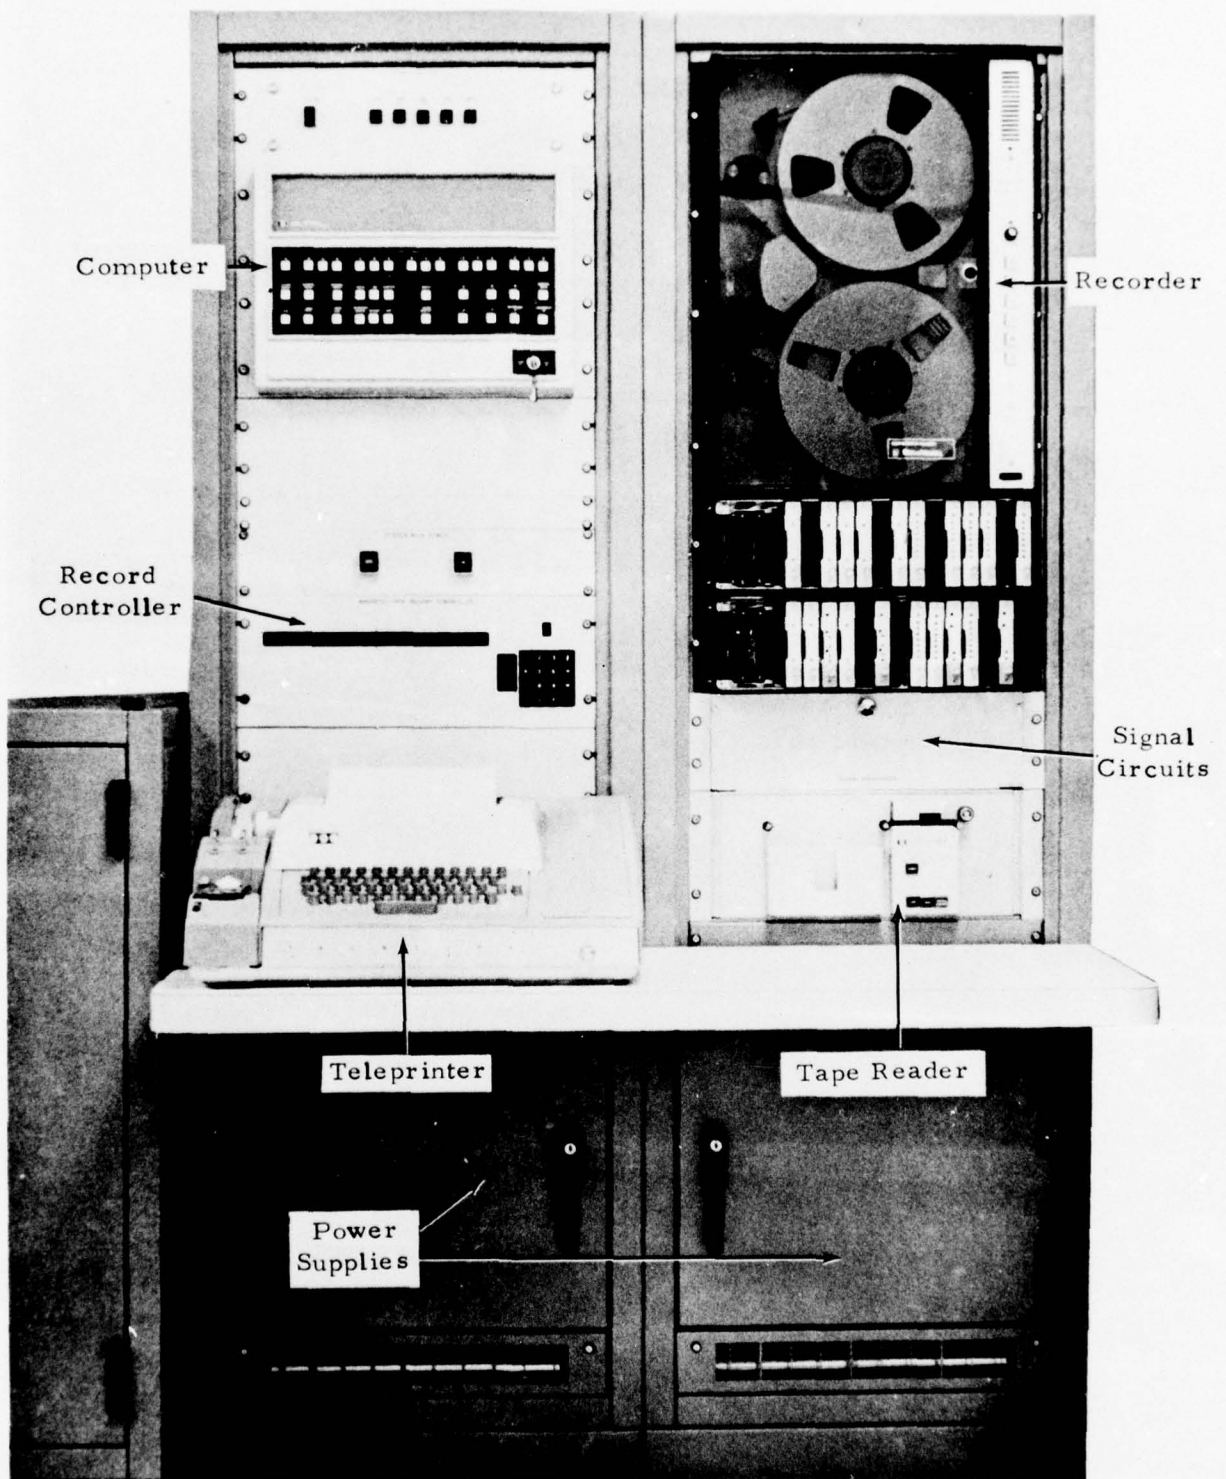
FIGURE 5. CONTROL CONSOLE

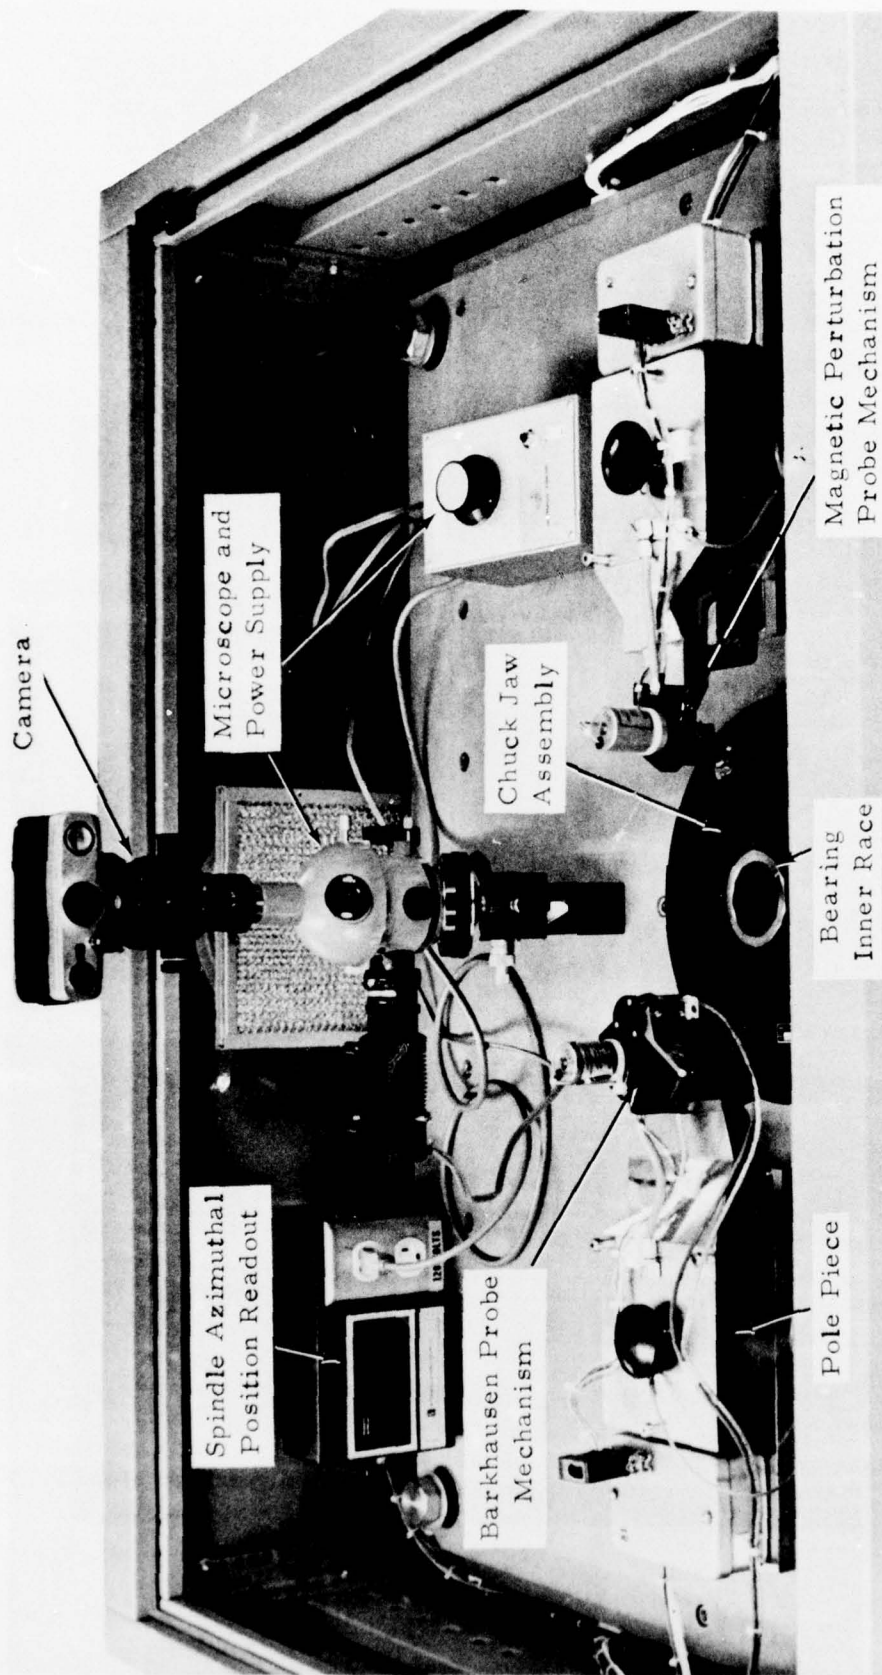
FIGURE 6. RACE INSPECTION UNIT

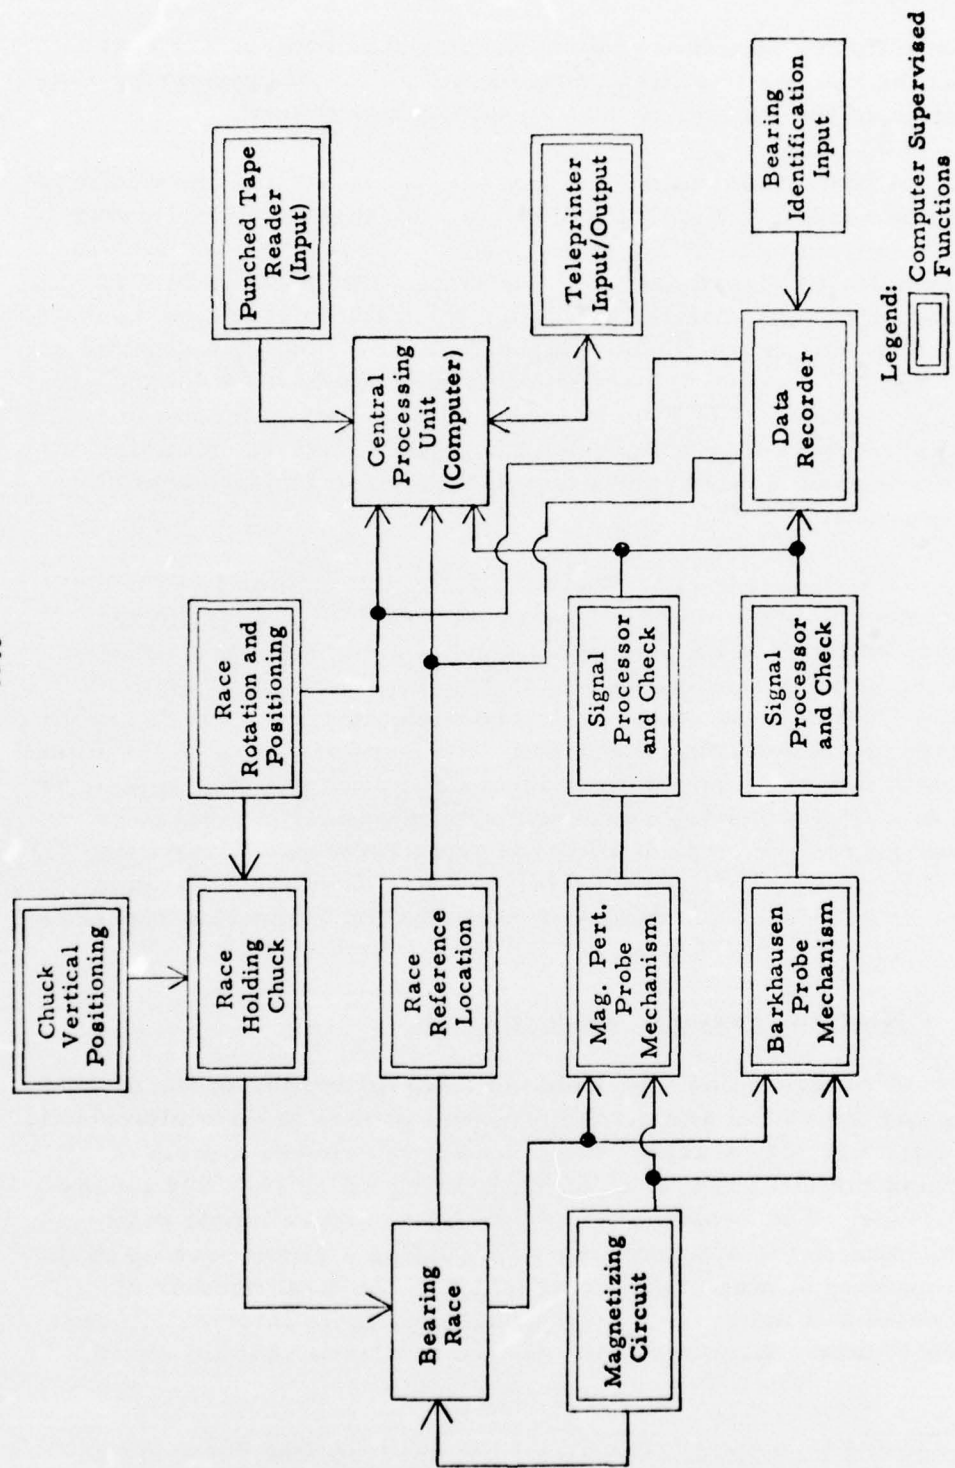
FIGURE 7. FUNCTIONAL DIAGRAM OF BEARING RACE INSPECTION SYSTEM

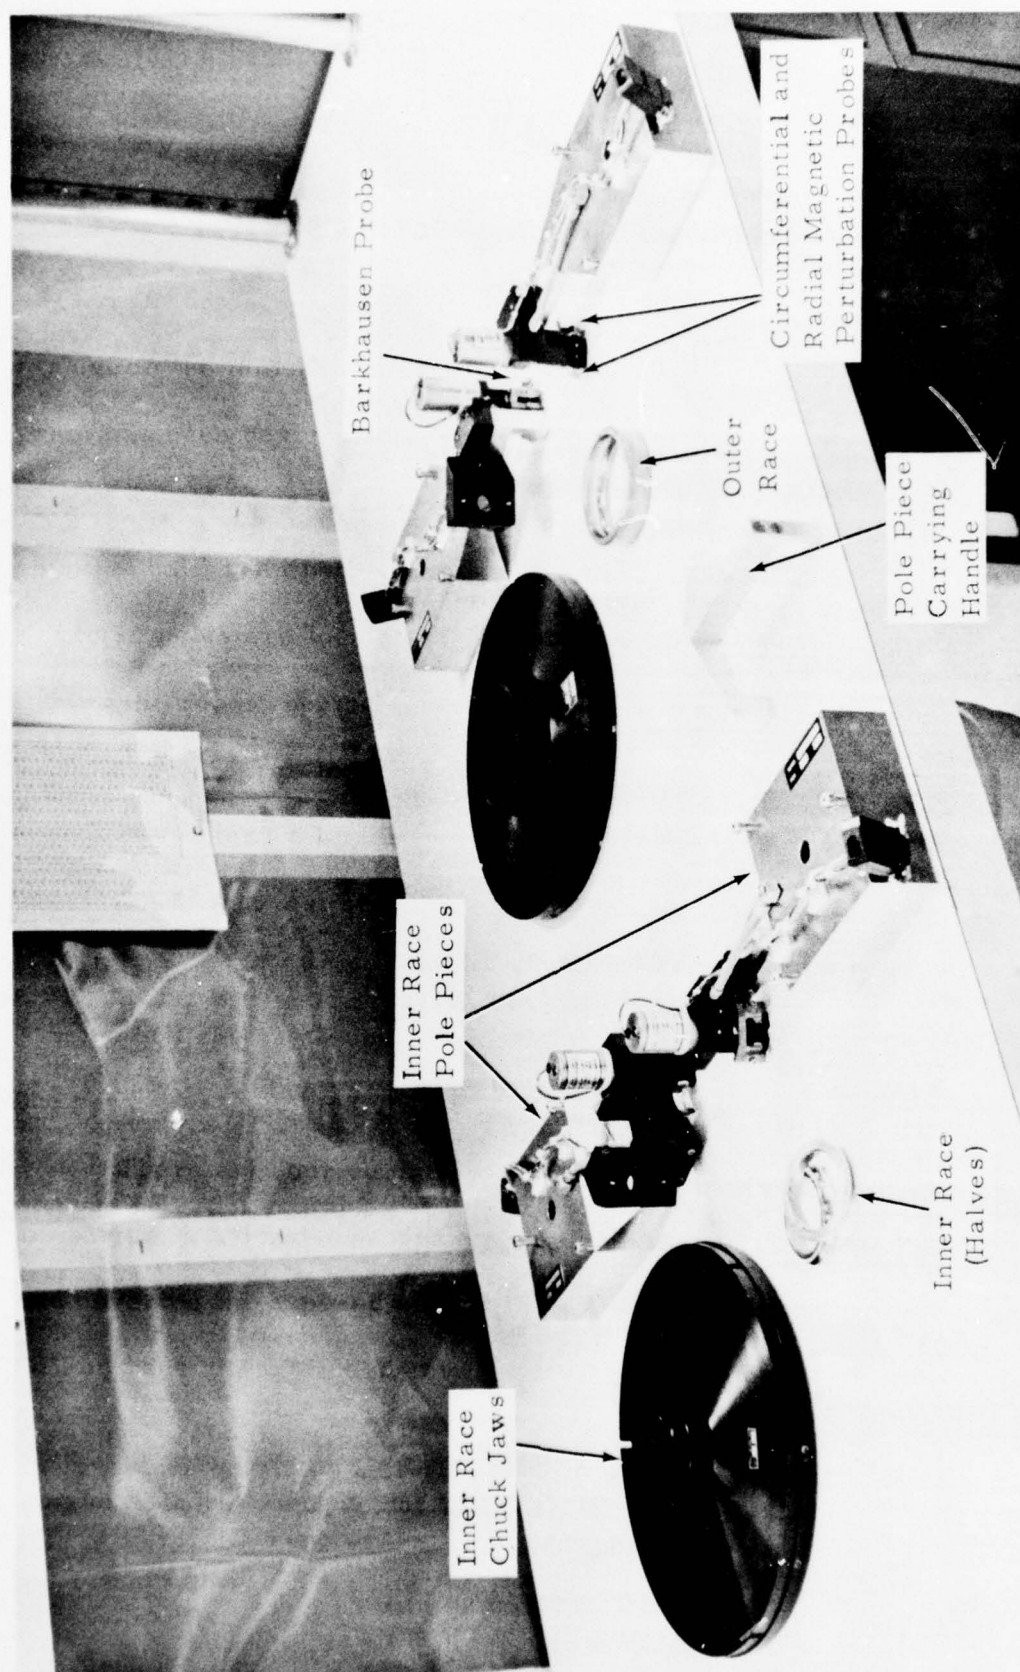
FIGURE 8. TYPICAL RACE ELEMENT INSPECTION FIXTURES

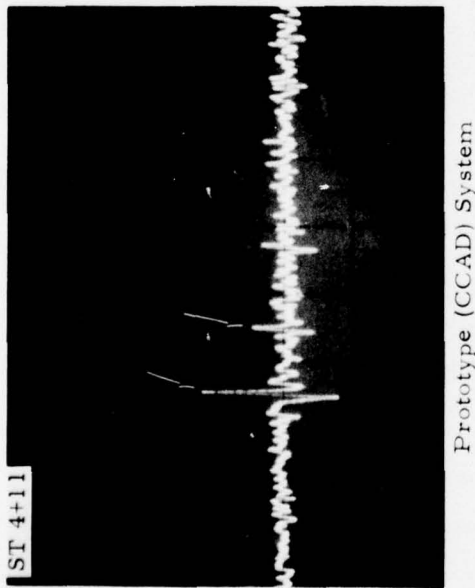
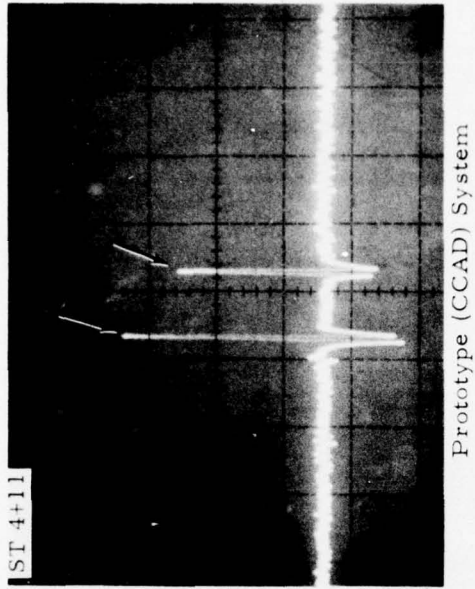
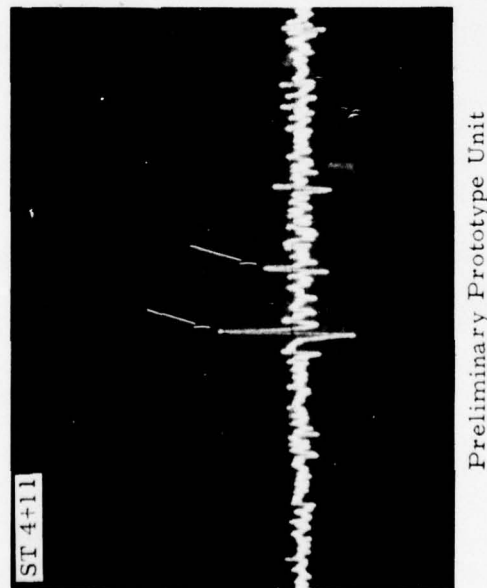
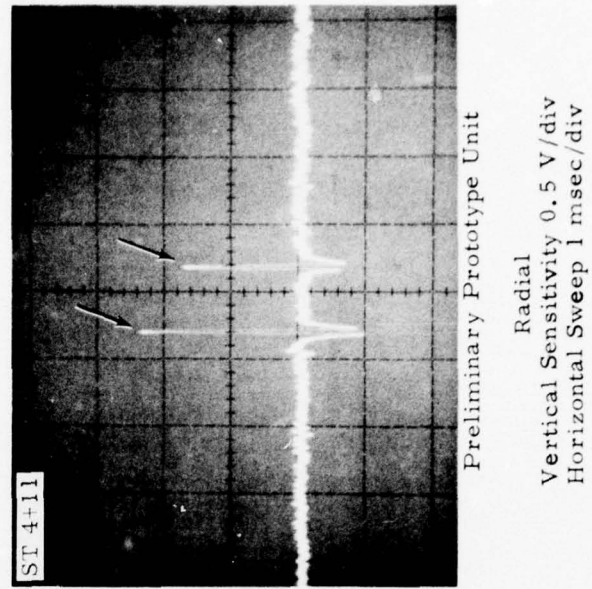
FIGURE 11. COMPARISON OF PROTOTYPE (CCAD) AND PRELIMINARY PROTOTYPE UNIT MAGNETIC PERTURBATION SIGNATURES FROM MANUFACTURED DEFECTS IN SAME INNER RACE (PN 1-300-015, S/N 759P)

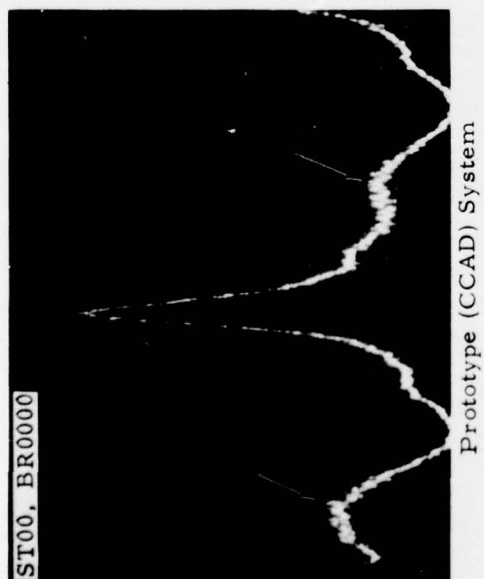
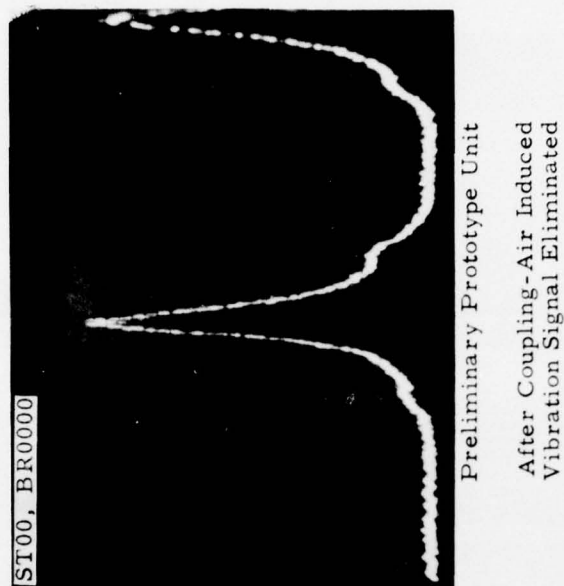
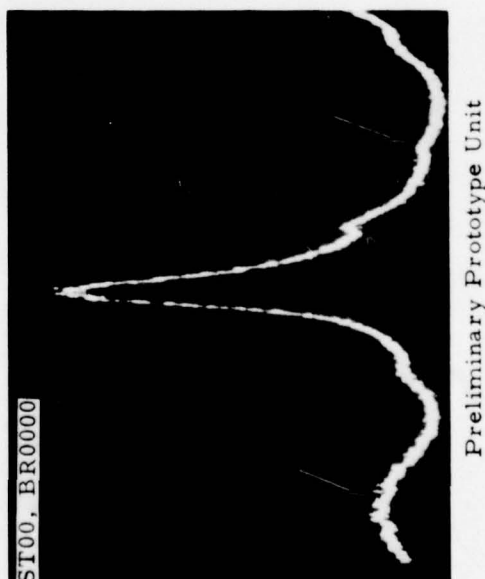
Vertical Sensitivity 50 mV/div
Horizontal Sweep 0.2 sec/div

FIGURE 12. COMPARISON OF PROTOTYPE (CCAD) AND PRELIMINARY PROTOTYPE UNIT BARK-HAUSEN SIGNATURES FROM SAME INNER RACE (PN 1-300-015, S/N 759P) (Before and After Elimination of Air Induced Vibration Signal)

of this accessory set was postponed pending further checks on this Barkhausen signature. Furthermore, during operational checkout of the preliminary prototype unit, an unusual Barkhausen signature was noted on the 1-300-015 outer race which contained shape characteristics very similar to those observed on the 204-040-346/205-040-246 inner race accessory set. This anomalous Barkhausen signature shape was not noted for the same 1-300-015 outer race on the prototype (CCAD) system. In-depth investigations were made by changing out Barkhausen probe, preamplifier, and other signal system components several times but the improper Barkhausen signature persisted. However, when the unprocessed Barkhausen signature was viewed on a much expanded time scale, a periodic signal of approximately 200 kHz was observed to occur in synchronization with the time-varying applied magnetic field. Subsequent investigation revealed that the probe coupling air was inducing a high frequency mechanical vibration (~ 200 kHz) in the Barkhausen probe pickup coil which resulted in the generation of an electrical signal in the Barkhausen probe via the time-varying applied magnetizing field. The influence of the probe coupling air is illustrated by the records in Figure A15. Note the anomalous Barkhausen signature in the upper record with normal air coupling and the absence of the anomalous signal component when the probe air is turned off (see lower record). It was concluded that i) in those cases where the anticipated Barkhausen signature shape is obtained, all probe coil turns were bonded to the probe coil form, and ii) in those cases where an improper shaped signature was obtained, the face turns of the probe coil were not tightly bonded to the coil form. Based on this rationale, new Barkhausen probes were fabricated where all coil turns were carefully bonded to the coil form. The results of this effort in alleviating the air-induced mechanical vibration problem was previously illustrated in Figure 12 in this report.

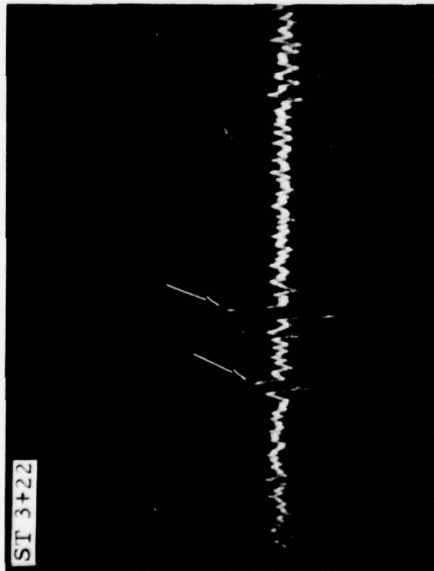
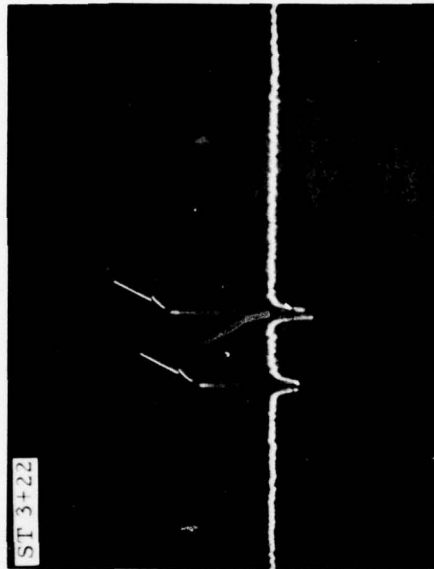
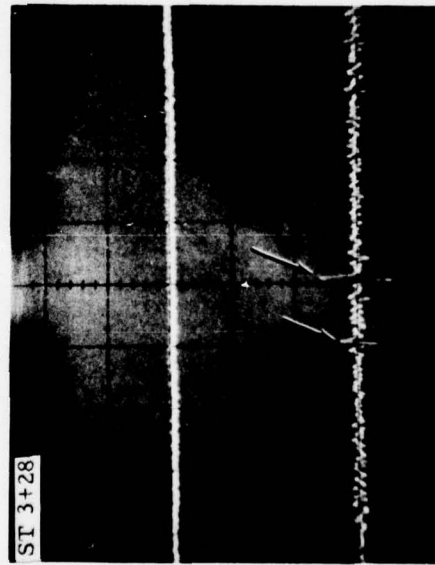
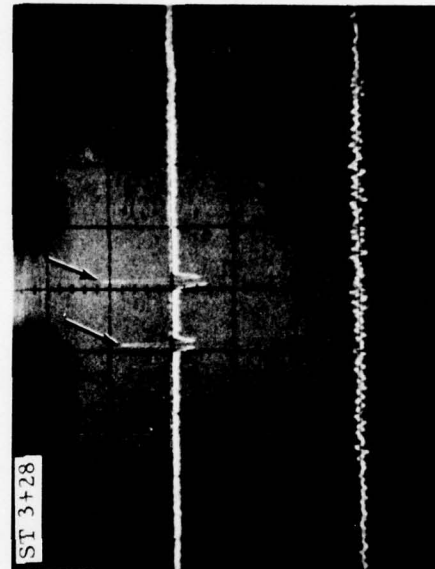
FIGURE 13. COMPARISON OF PROTOTYPE (CCAD) AND PRELIMINARY PROTOTYPE UNIT MAGNETIC PERTURBATION SIGNATURES FROM MANUFACTURED DEFECTS IN SAME OUTER RACE (PN 1-300-015, S/N 759P)

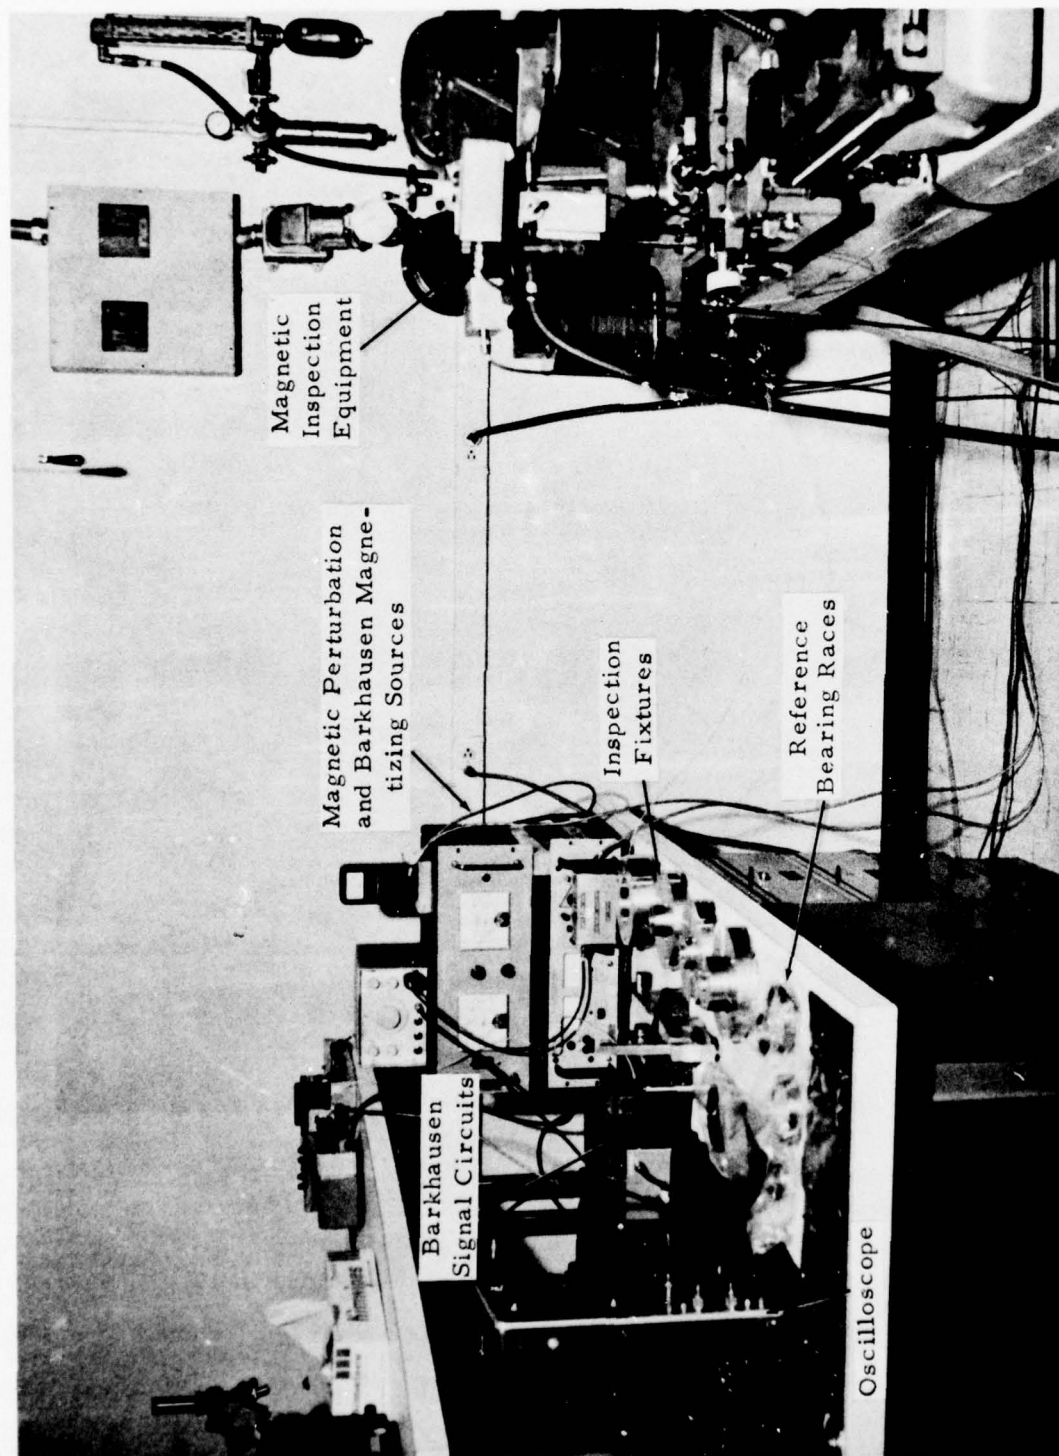
FIGURE 15. LABORATORY APPARATUS FOR MAGNETIC PERTURBATION AND BARKHAUSEN NOISE INSPECTIONS

The apparatus used for magnetic perturbation inspection of bearing races is illustrated in Figure 15. This apparatus facilitated the acquisition of magnetic perturbation circumferential and Barkhausen noise data on both inner and outer races. The laboratory apparatus in Figure 16 was used to acquire laser scattered light data. Such inspections were conducted on 20 each reference Part Number 1-300-015-04 (ITI PN 13701), 20 each reference Part Number 1-300-176-03 (ITI PN 13700), engine main shaft bearings and 20 sets of 3 each reference Part Number 205-040-246-3 (ITI PN 13699) transmission bearings. Several magnetic perturbation signatures considered significant were selected for more careful study and correlation examination with the physical surface of the raceway; a number of these locations have been reported on previously. However, because of unusual observations associated with a selected signature region, subsequent laboratory follow-up work was undertaken. Figures 17, 18, and 19 illustrate the results of an investigation only recently completed of this unusual region. In the upper record of Figure 17 the signal of interest is pointed out by the arrow; the lower record shows the same signature but with the horizontal scale expanded. This circumferential signature is well-shaped, with good symmetry (equally downward going and upward going peaks), and has void polarity indicative of a pit, hole or nonmetallic inclusion probably at or near the raceway surface. Both optical and scanning electron microscope (SEM) micrographs of the raceway region corresponding to the signal are presented in Figure 18. The very regular and uniform nature of the enclosing nearly perfect circular pattern generated intense interest in this region. Additional SEM examination at higher magnifications were undertaken of the region enclosed by the circular outline; regions marked A and B in the SEM micrograph at the bottom of Figure 18 are illustrated at higher magnification in Figure 19. The apparent cause of the magnetic perturbation signature is rust or corrosion and it is not superficial but probably extends 0.0005 to 0.0015 inches (0.013 to 0.038 mm) deep. The network of fine, crack-like lines in regions A and B (Figure 19) are apparently the result of oxide formation. This conclusion is supported by the X-ray fluorescence scan for oxygen in region B; note the dot pattern in the X-ray image of Figure 19 appears to correlate well with the visual elements of oxide evident in the SEM micrograph immediately to the left.

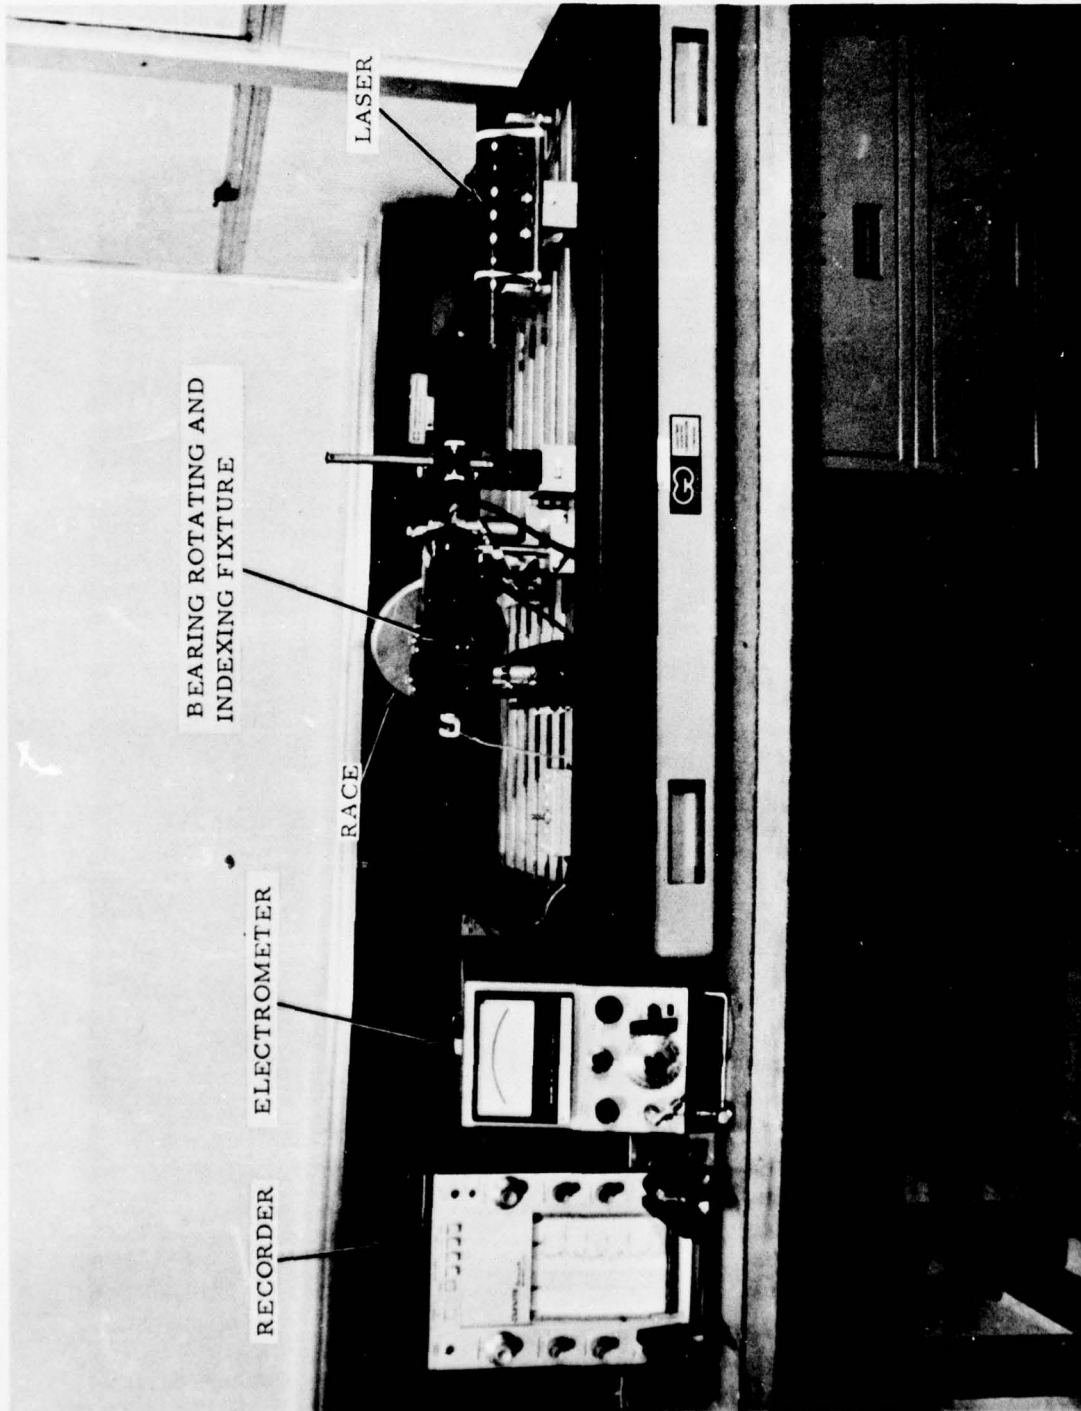
FIGURE 16. OVERALL VIEW OF OPTICAL INSPECTION SYSTEM

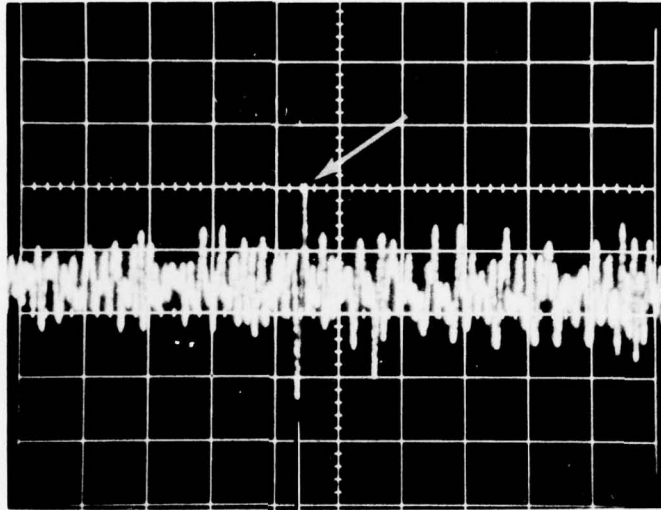
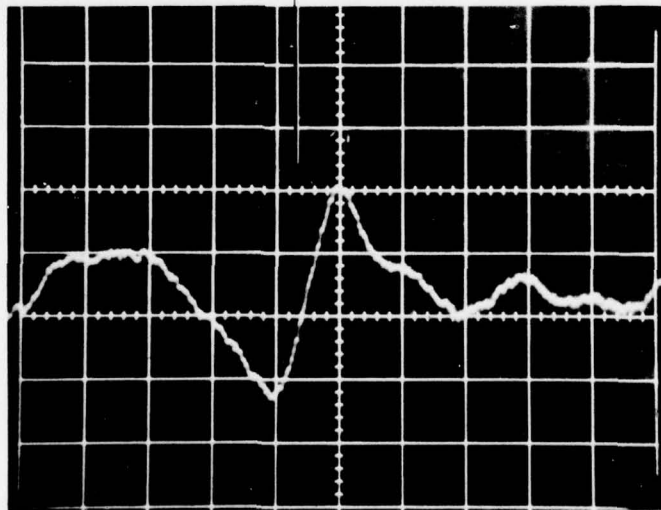
FIGURE 17. SELECTED MAGNETIC PERTURBATION CIRCUMFERENTIAL (High Field) RECORDS FROM A P/N 1-300-015, S/N 28, Side 2 (344°) REWORKED INNER RACE

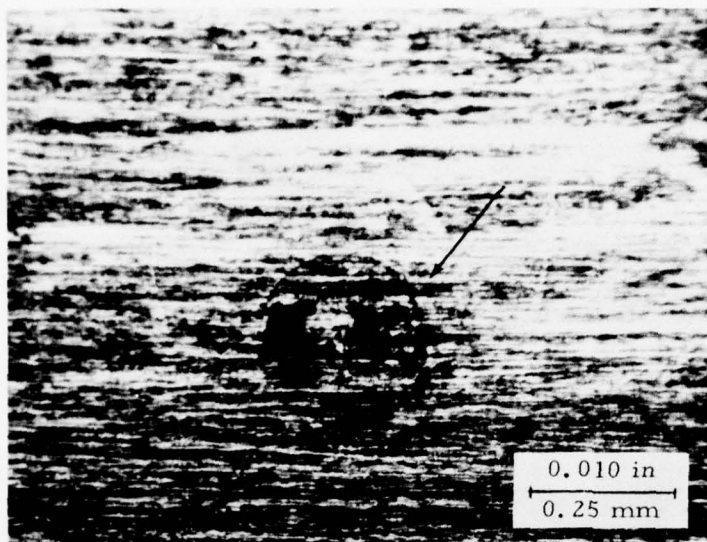
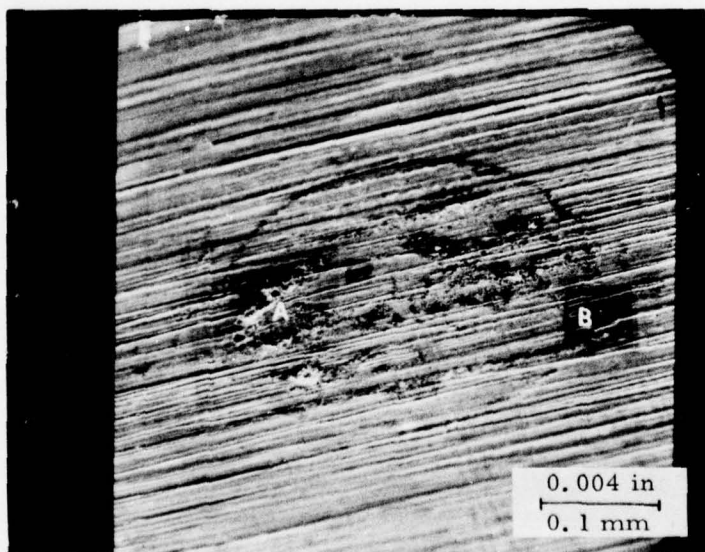
FIGURE 18. OPTICAL AND SEM MICROGRAPHS OF RACE SURFACE
CORRESPONDING TO MAGNETIC PERTURBATION CIR-
CUMFERENTIAL SIGNATURE

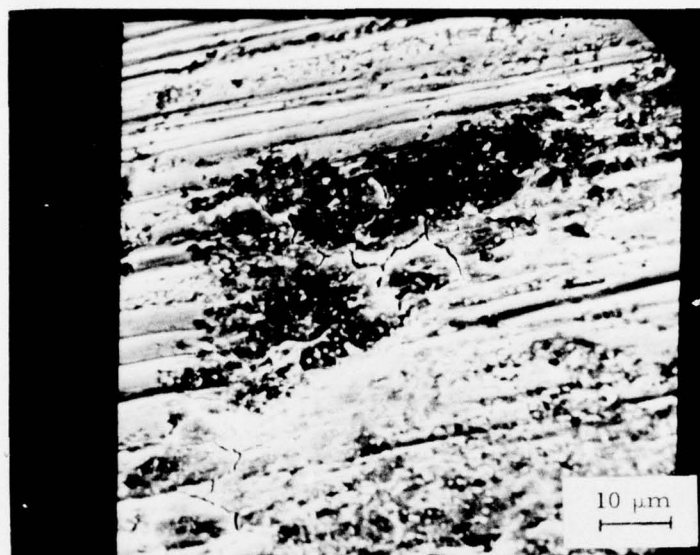
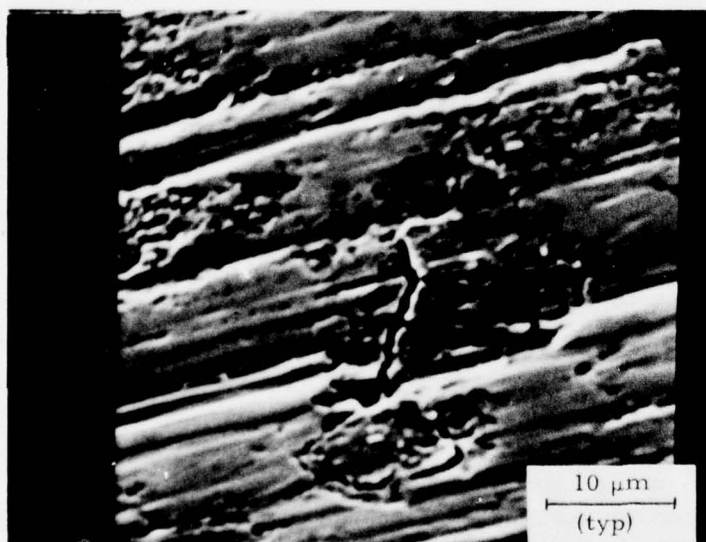
FIGURE 19. SEM AND FLUORESCENCE MICROGRAPHS OF REGIONS
A AND B
